Pearce Creek DMCF Exterior Monitoring Post-Placement Sampling Fall 2020 Results

Pearce Creek Implementation Committee
May 2021

Project Overview

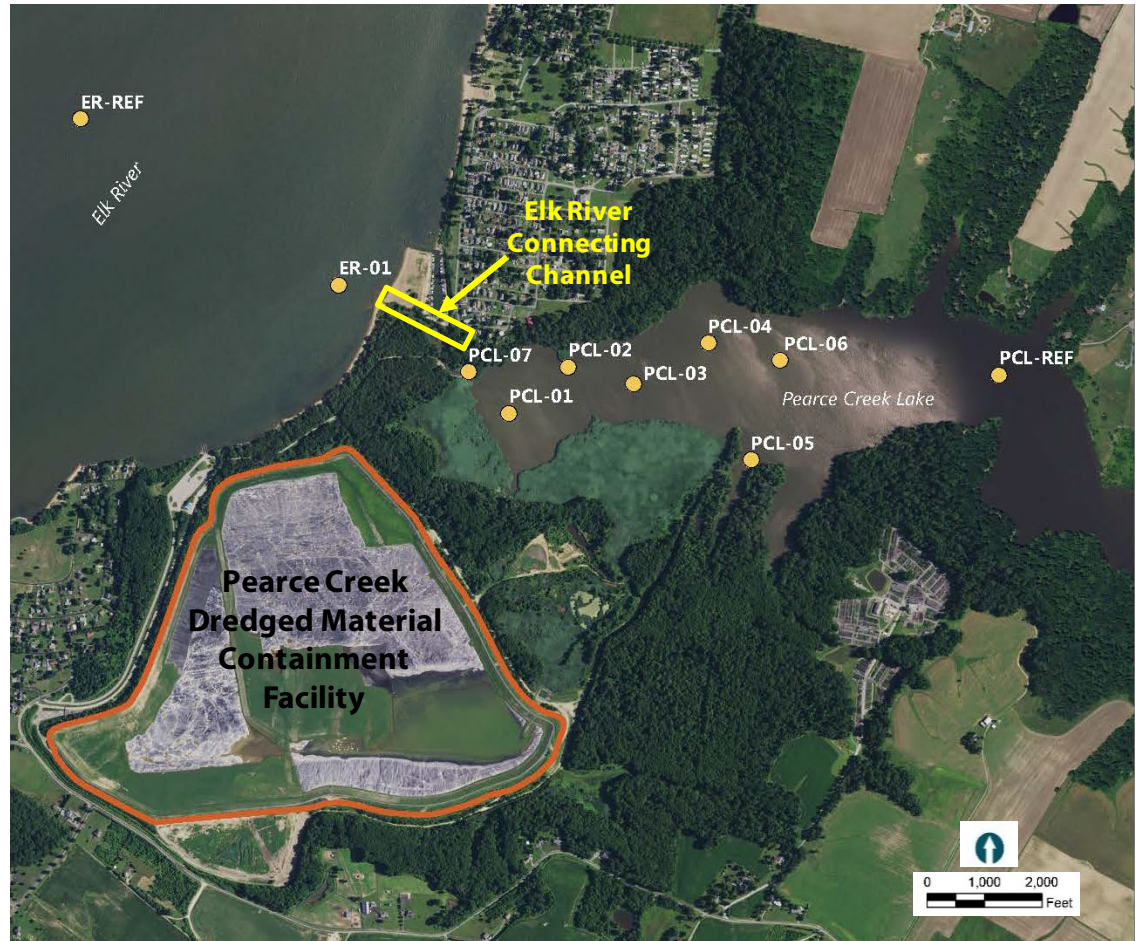
- 10 Sampling Locations:
 - 7 Pearce Creek Lake monitoring locations
 - 1 Pearce Creek Lake reference site
 - 1 Elk River monitoring location
 - 1 Elk River reference site
- Reference sites represent areas that are outside of the influence of the DMCF

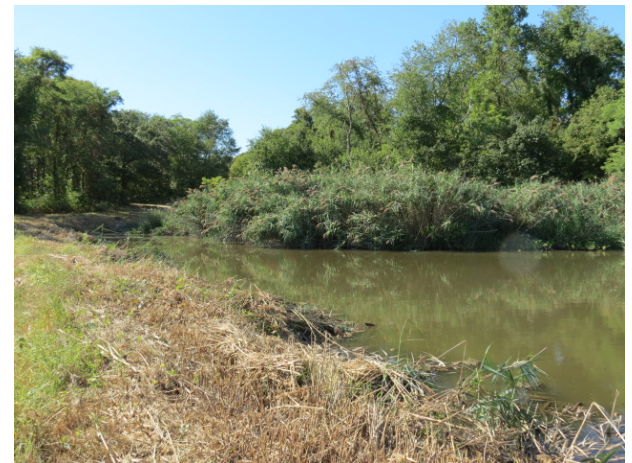
Location PCL-07

- Post-placement data comparable between the reference and the monitoring locations
- Post-placement data were also generally within the range of baseline concentrations
- Sediment Type
 - Pearce Creek Lake monitoring locations comprised of silts and clays, except PCL-07 (sands)
 - Pearce Creek Lake reference location comprised of silts and clays
 - Elk River monitoring location was silty clays
 - Elk River reference location was comprised of silty clays, with a lot of shell material
- Nutrients: Concentrations naturally variable at all locations

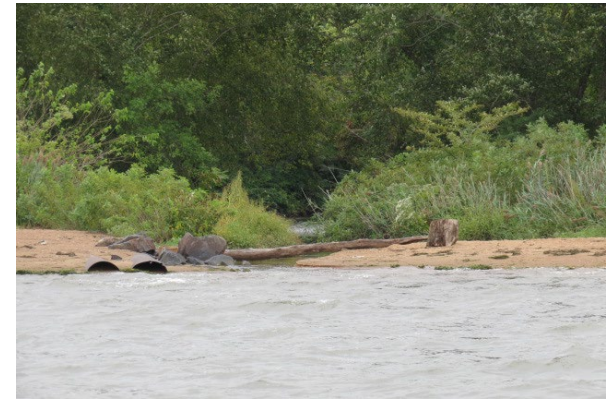
Elk River Connecting Channel – Elk River Outlet at High Tide

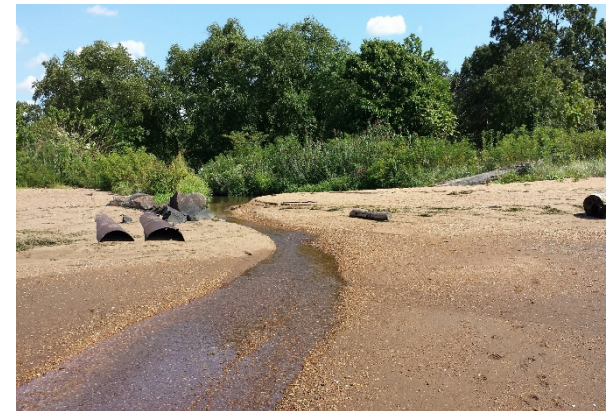
Elk River Connecting Channel – Elk River Outlet at Low Tide

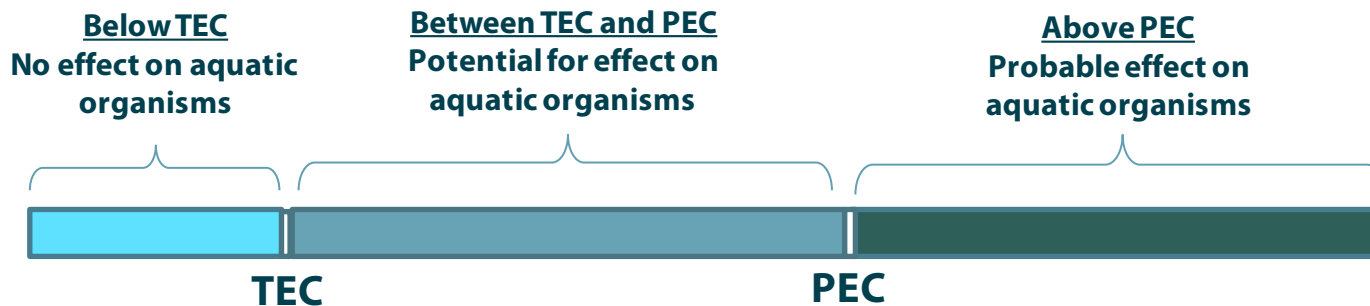
- Results of chemical testing were compared to freshwater sediment guidelines
 - Derived by scientific community based on actual sediment concentrations
 - Each chemical has two values:
 - A threshold effect concentration (TEC)
 - A probable effect concentration (PEC)

- An “effect” means that an organism’s behavior is impacted, such as a slow down of organism growth rate
- “Effects” do not indicate mortality

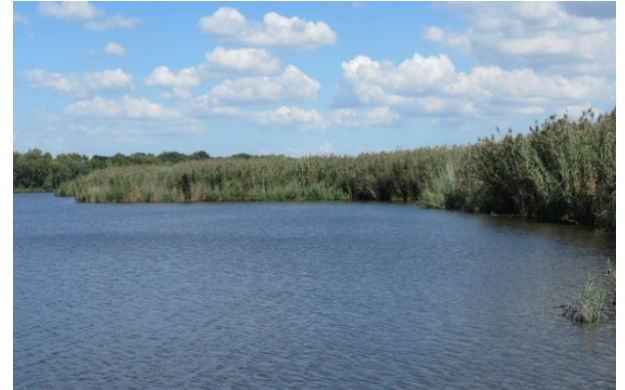
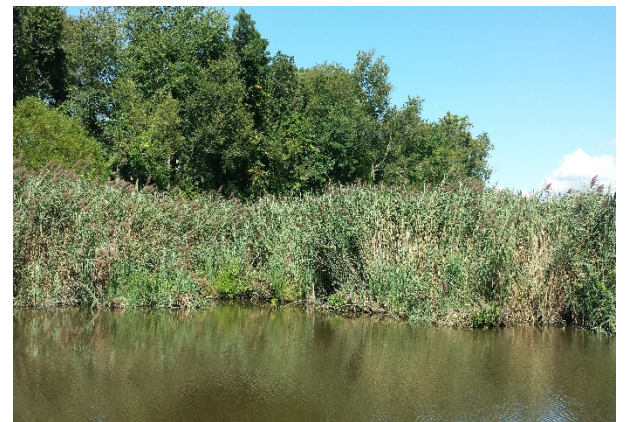
- 10-day whole sediment toxicity testing using *Hyallela azteca*: freshwater amphipod (laboratory cultured)
- Results for each location compared to reference site and to baseline data
- Results are consistent with the baseline data
 - Survival high for the Pearce Creek Lake and Elk River sediments
 - Sediments support benthic organisms

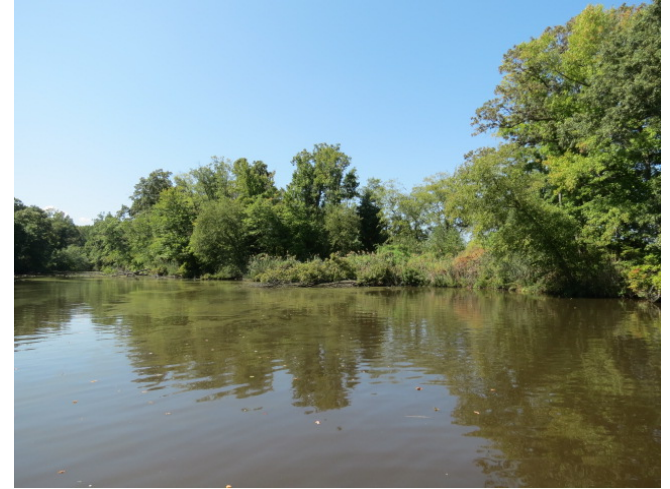
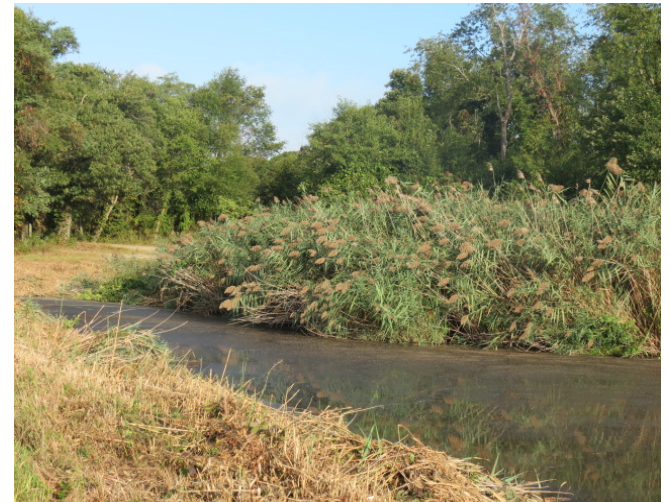
- Most of the metrics were within the range of the baseline data
- Abundance is highly variable at each location, but consistent with the baseline data (within the range of data observed previously)
- Indicates that while there is localized variability, the overall benthic community condition has not substantially changed compared to baseline monitoring results

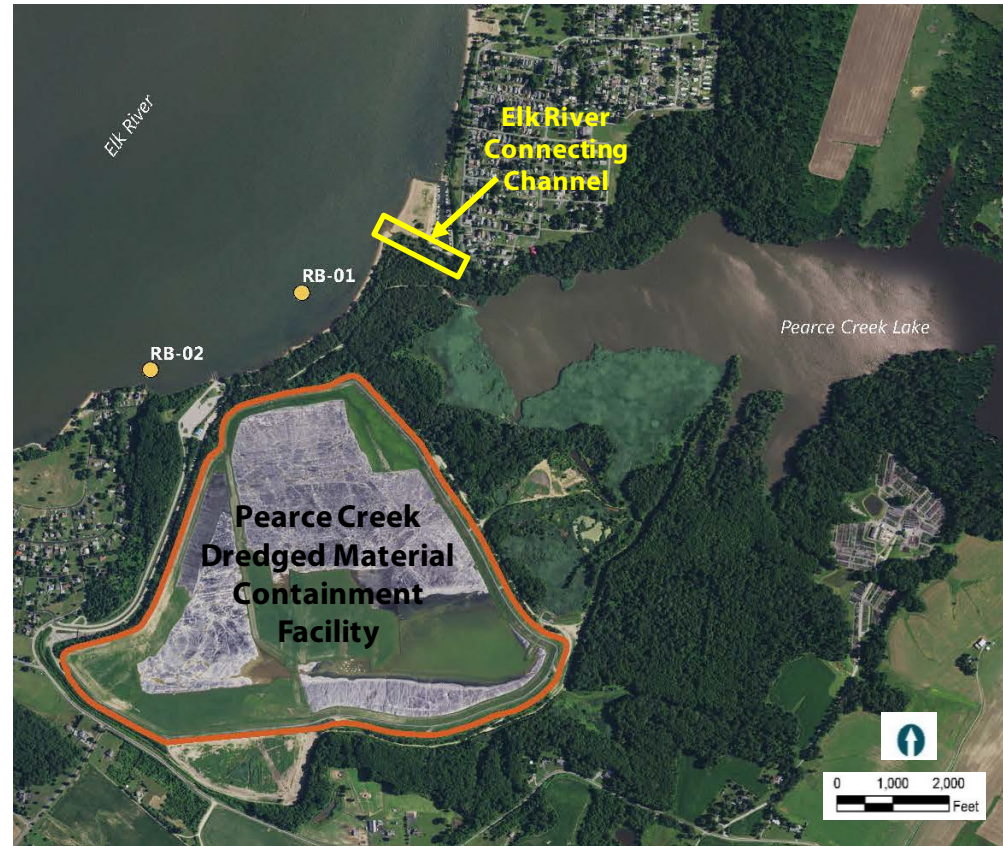
- Samples collected in nearshore areas close to beach areas in the Elk River
- Added at the request of citizen members of the PCIC
- Evaluated independently from the exterior monitoring data
- Samples were collected on October 5-6, 2020
- Included same testing program
 - Sediment
 - Water quality
 - Benthic community
 - Benthic bioassays

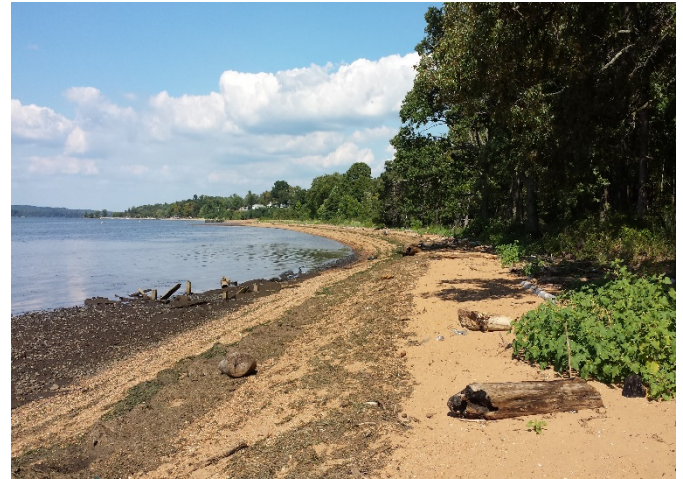
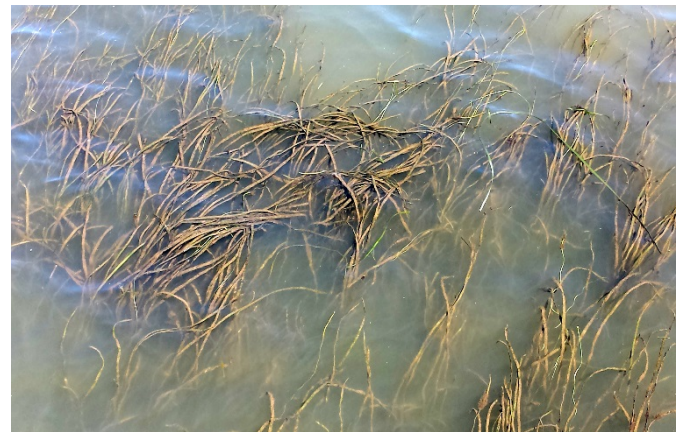
- Locations were classified as oligohaline (3.4 and 3.7 ppt)
- Turbidity was low (7.0 and 4.8 NTUs)
- Chemical Testing
 - Concentrations are very low; consistent with previous sampling
 - None of the samples had chemical concentrations that exceeded water quality criteria

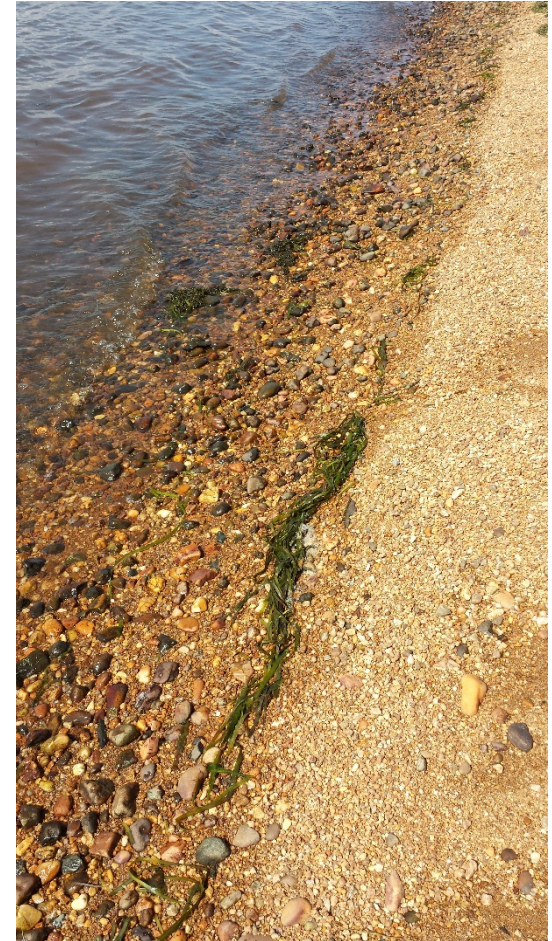
- Sediment Type
 - Location 1 (RB-01) was mostly sand
 - Location 2 (RB-02) was primarily sand with some shell fragments
- Nutrients and Metals
 - Nutrient concentrations naturally variable
 - Metal concentrations generally low and well below the sediment quality criteria
 - None of the metals exceeded TEC values
 - Results consistent with previous sampling events

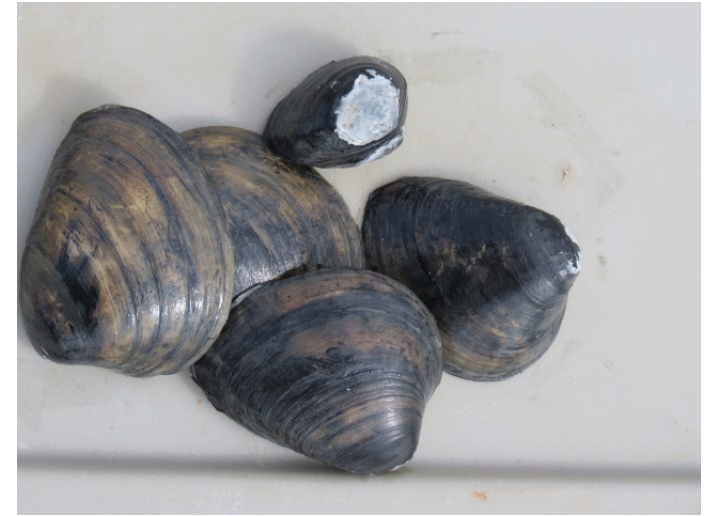
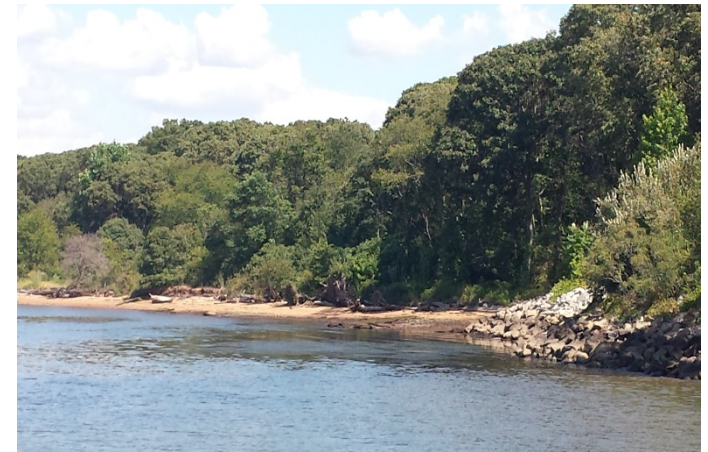
- Benthic Community
 - Abundance variable, but generally consistent with previous sampling events
- Benthic Bioassays
 - Both samples had high survival, therefore the sediment supports benthic organisms
