# Pearce Creek DMCF Exterior Monitoring Post-Placement Sampling Spring 2019 Results

Pearce Creek Implementation Committee  
November 15, 2019

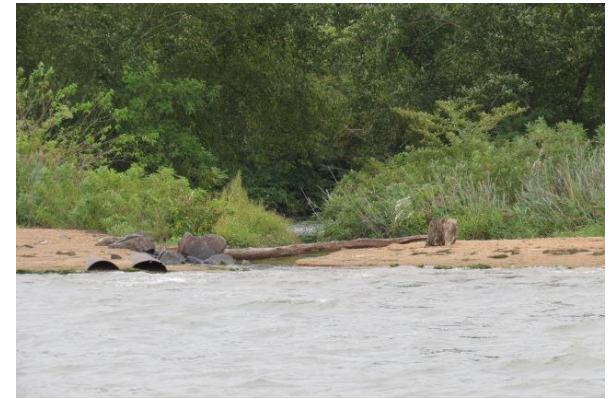
**Elk River Connecting Channel – Elk River Outlet at High Tide**

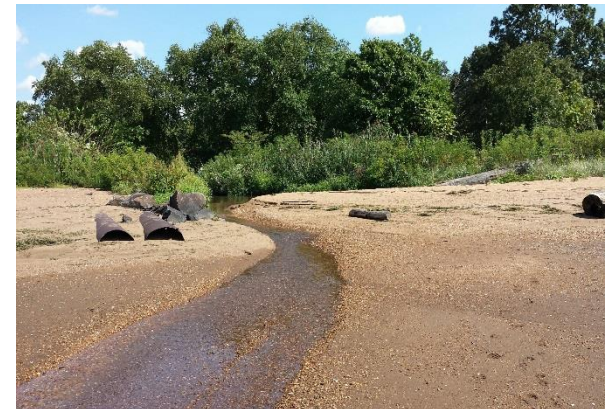
**Elk River Connecting Channel – Elk River Outlet at Low Tide**

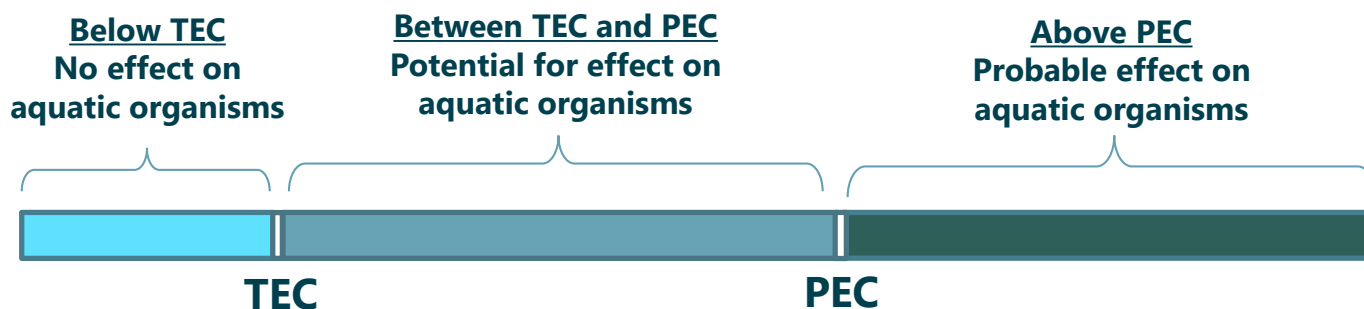
- Results of chemical testing were compared to freshwater sediment guidelines
  - Derived by scientific community based on actual sediment concentrations
  - Each chemical has two values:
    - A threshold effect concentration (TEC)
    - A probable effect concentration (PEC)

- An “effect” means that an organism’s behavior is impacted, such as a slow down of organism growth rate
- “Effects” do not indicate mortality

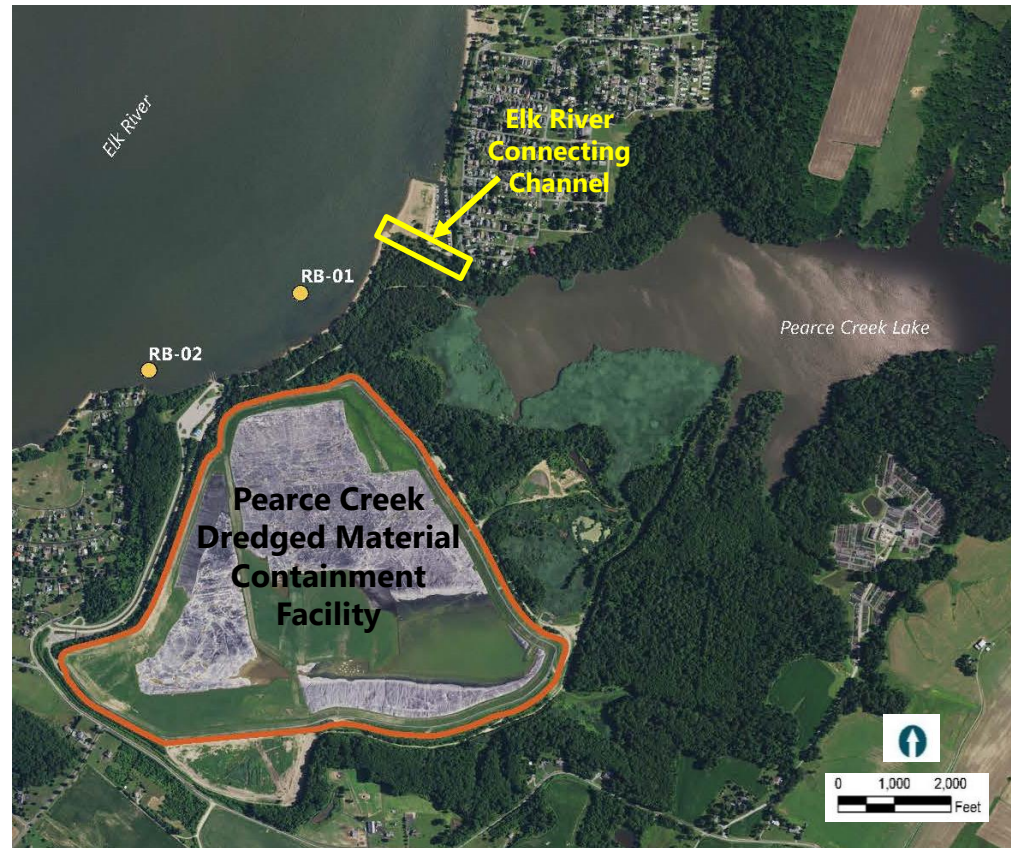
- Samples collected in nearshore areas close to beach areas in the Elk River
- Added at the request of citizen members of the PCIC
- Evaluated independently from the exterior monitoring data
- Samples were collected on May 22, 2019
- Included same testing program
  - Sediment
  - Water quality
  - Benthic community
  - Benthic bioassays

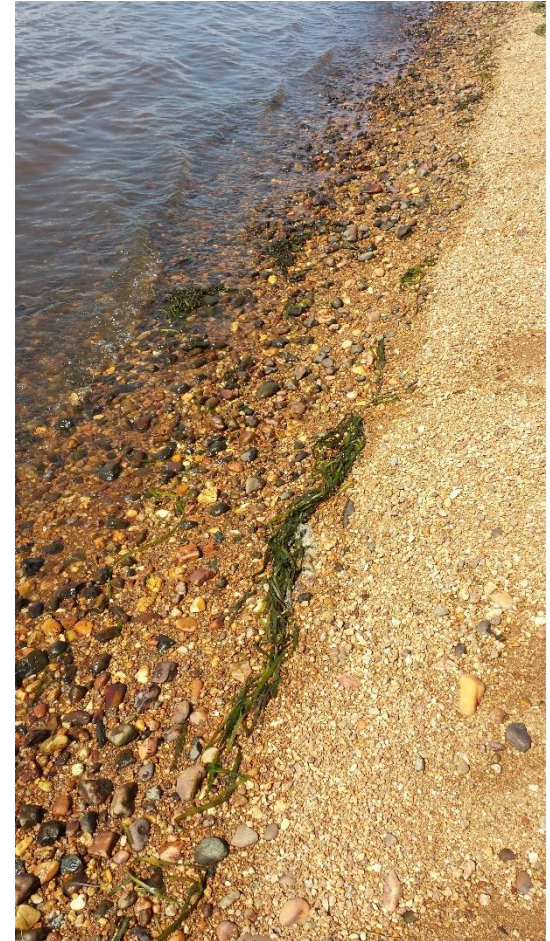
- Sediment Type
  - Location 1 (RB-01) was mostly sand
  - Location 2 (RB-02) was primarily sand with some shell fragments
- Nutrients and Metals
  - Nutrient concentrations naturally variable
  - Metal concentrations generally low and well below the sediment quality criteria
  - None of the metals exceeded TEC values
  - Results consistent with previous sampling events

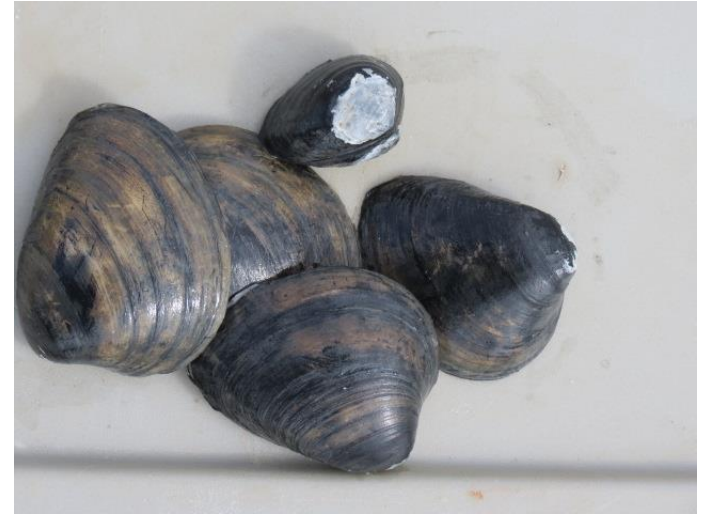
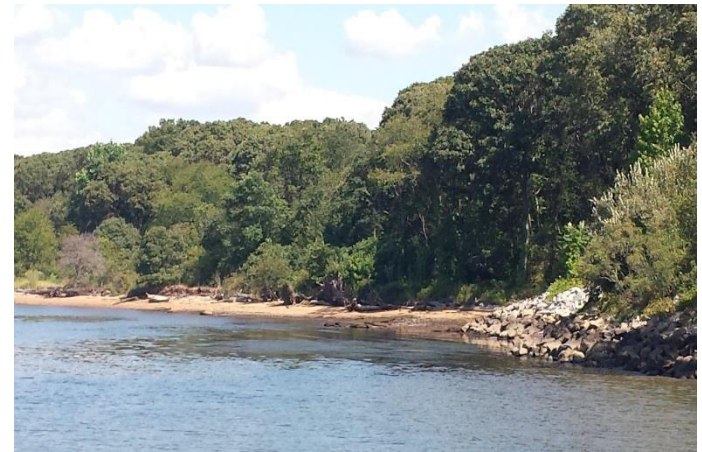
- Benthic Community
  - Abundance variable, but generally consistent with previous sampling events
- Benthic Bioassays
  - Both samples had high survival, therefore the sediment supports benthic organisms
