# PEARCE CREEK DREDGED MATERIAL CONTAINMENT FACILITY EXTERIOR MONITORING PROGRAM FALL 2020 POST-PLACEMENT RESULTS

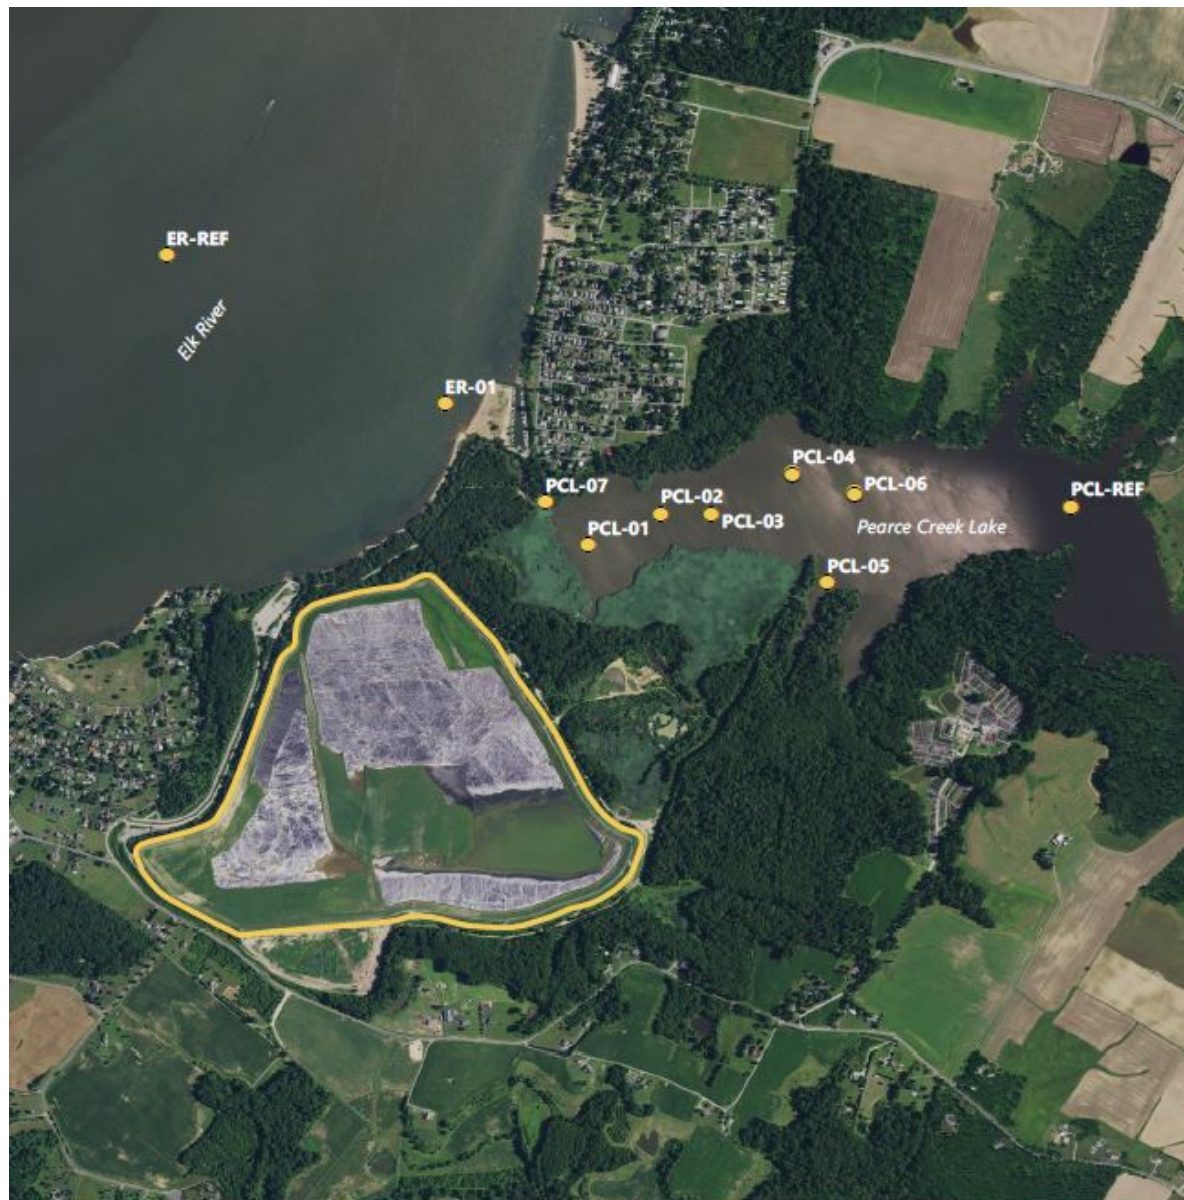
**FIGURE 1. EXTERIOR MONITORING LOCATIONS**

This data summary details the results of the fall 2020 post-placement monitoring event, which was conducted in October 2020 and included sample collection from seven monitoring locations and one reference location in Pearce Creek Lake, and one monitoring location and one reference location in the Elk River (Figure 1). Reference locations measure natural changes in background conditions and are located in areas that are outside of the influence of the DMCF operations. Results from the reference locations are compared to the results from the monitoring locations to evaluate if inputs from the surrounding watershed may be influencing conditions in Pearce Creek Lake or the Elk River.

Eight surface water samples were collected from Pearce Creek Lake, and two surface water samples were collected from the Elk River (Figure 1). In addition to measuring the surface water conditions when the samples were collected—such as water temperature, oxygen content, and water clarity (turbidity)—the surface water samples were also sent to a certified laboratory. Laboratory tests for the water samples included metals, phosphorus, nitrogen, ammonia, and suspended solids. This list was chosen to represent the composition of surface water runoff and soil erosion, which provide the majority of the surface water that flows into Pearce Creek Lake from the surrounding area.
